CoreLink™  
DMA Controller (DMA-330)  
**Errata Notice**

This document contains all errata known at the date of issue in releases up to and including revision r0p0 of PL330 AXI DMA Controller and revision r1p1 of DMA-330 CoreLink DMA Controller.

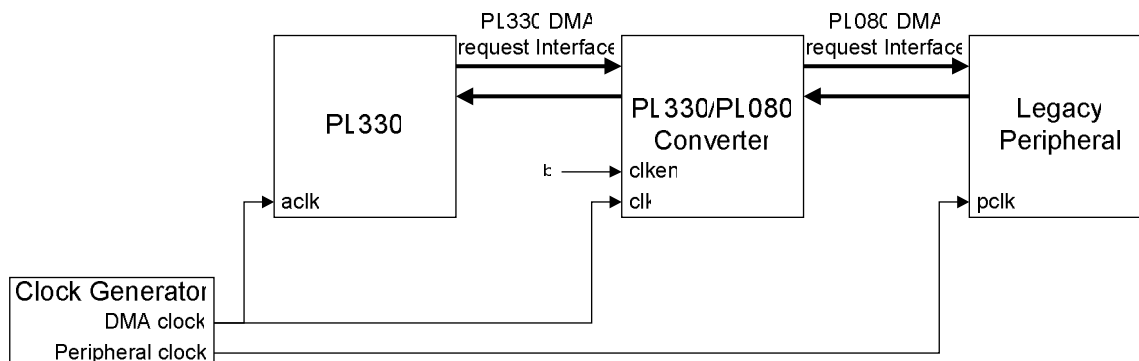
Appendix A of the PL330 Integration Manual describes the DMA Request Interface Converter, which allows you to connect a legacy peripheral that implements a PL080-style DMA request interface to PL330. Figure A-1 "Converter connections" on p.A-2 illustrates the integration of the converter block into a system but does not include the clken input port of the converter.

The purpose of the clken input is to allow the entire converter to run at a frequency lower than that of the clock connected to the clk input. If clken is not tied high, then only the rising edges of clk which coincide with clken=1 are used to advance the internal state of the converter. The converter must operate at the same frequency as PL330 so that the DMA request and acknowledge signals between the converter and PL330 are interpreted correctly by both components. Therefore you should integrate the converter by connecting its clk input to the same system clock as that which is connected to the aclk input of PL330, and tying the clken input high as shown in the following diagram.

Note that the PL080 DMA request interface is an asynchronous interface. Therefore the integration method illustrated above will work correctly as long as the frequency of the Peripheral clock is less than or equal to the DMA clock.
