ARM Infrastructure PrimeCell AXI-AHB Bridges (BP137) **Errata Notice**

This document contains all errata known at the date of issue in releases up to and including revision r0p1 of AXIToAHB

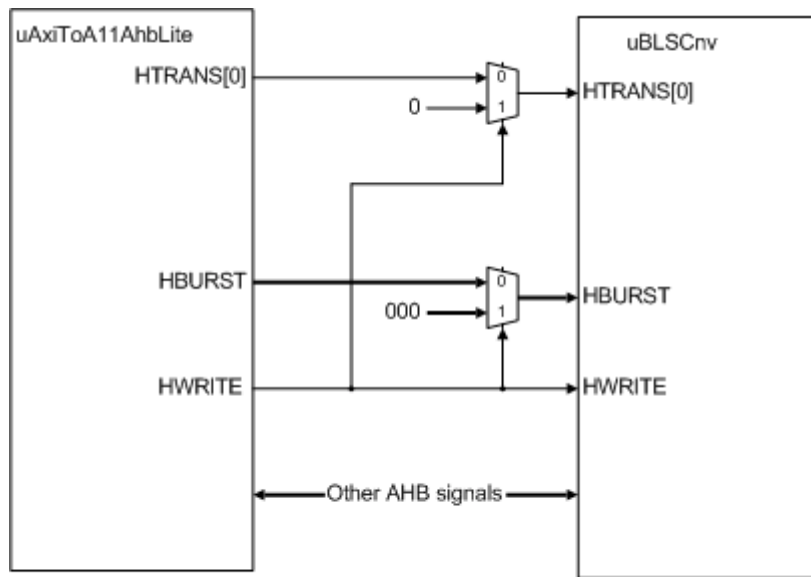
Figure 1 Override HTRANS[0] and HBURST to uBLSCnv for write bursts

The issue is that the AXI to ARM11 AHB-Lite bridge does not fully support sparse write bursts, i.e. where some bits of WSTRB are de-asserted in order to prevent the writing of certain bytes. The Design Manual correctly refers to a potential protocol violation on the output signal IHUNALIGN of this subcomponent of the AXI to AHB bridges. However, it omits to describe a possible consequent protocol violation on the AHB signals HTRANS, HBURST, and HSIZE at the outputs of the AxiToAhbLiteM or AxiToAhbLiteS variants of the AXI to AHB bridges.

The issue arises when an AXI write transaction begins with an aligned, non-sparse write transfer but one or more subsequent write transfers in the same transaction are sparse. This causes the internal signal IHUNALIGN to transition from low to high at the output of the module AxiToA11AhbLite, as described in the Design Manual. When IHUNALIGN goes high, the byte lane strobe converter (BLScnv) converts each data transfer into series of byte transfers and the outputs HBURST, HTRANS, and HSIZE of BLScnv change. This violates the AHB protocol because the AHB transaction is mid-burst.

This breaks the AHB protocol, because HTRANS must not change from SEQ to NONSEQ, HBURST must not change from INCR8 to INCR, and HSIZE must not change from SIZE32 to SIZE8 until the first burst completes or is cancelled due to an error response.

If the bridge is used with a master that can generate the type of write transaction described, then the break of AHB protocol may cause a slave to exhibit UNPREDICTABLE behavior. Note that the ARM PrimeCell L220 Level 2 Cache Controller (AC131) can cause this problem. The workaround described below should be employed in this case.

You should either ensure that the AXI master does not generate write transactions that begin with an aligned, non-sparse write transfer but subsequently include a sparse write transfer, or use the workaround documented in Section 2.2.12 of the Design Manual:

“Every AXI write burst must be converted into a string of single, length = 1, AHB bursts by forcing HBURST to SINGLE, 0b000, or INCR, 0b001, and forcing HTRANS[0] LOW.”

In AxiToAhbLiteM and AxiToAhbLiteS, override the HBURST input to the module uBLSCnv to SINGLE (3'b000) or INCR (3'b001), and override the HTRANS[0] input to the module uBLSCnv to LOW(1'b0) during write bursts. This is shown in Figure 1 below:
