ETB Rev0 Errata List

CPU Cores Division

Document number: **ETB-PRDC-001103 17.0**
Date of Issue: 11 February 2011
Author: ARM

This document describes the known errata in the Embedded Trace Buffer design.

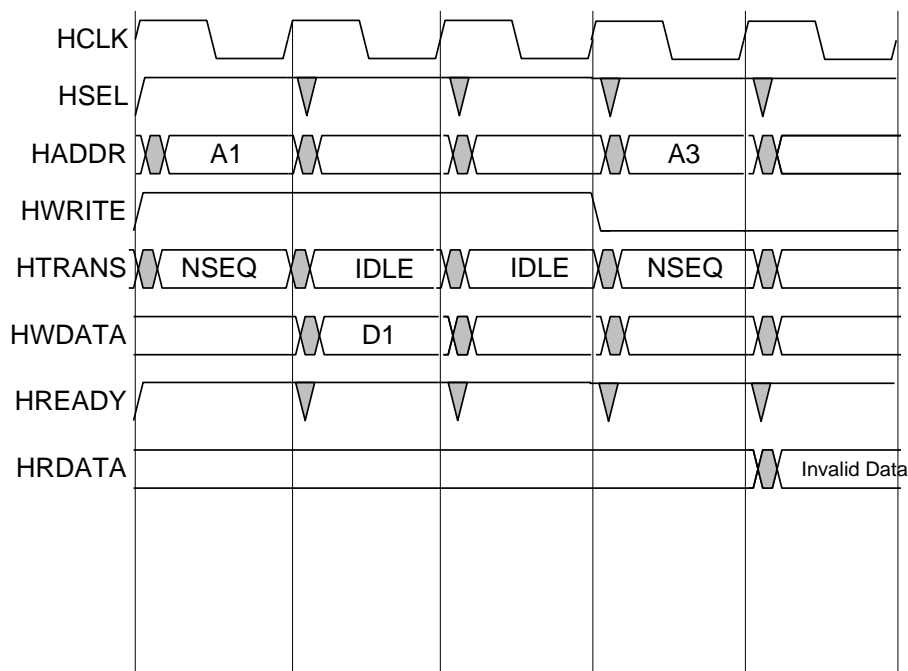
Figure 1: Waveform Diagram

JTAG access to the ETB is unaffected.

An undefined data value is written to the intended RAM read location and the returned read value is undefined.

There are no known workarounds for this erratum in existing designs. For new designs, this erratum can be avoided by using the ETB in asynchronous mode (by tying **SBYPASS** to 0).
