ARM926EJ-S Errata List

Document number: **ARM926EJ-PRDC-002691 5.0**

Date of Issue: 28th March 2007

This document describes the known errata in the ARM926EJ-S design indicating which errata are present in each product revision.

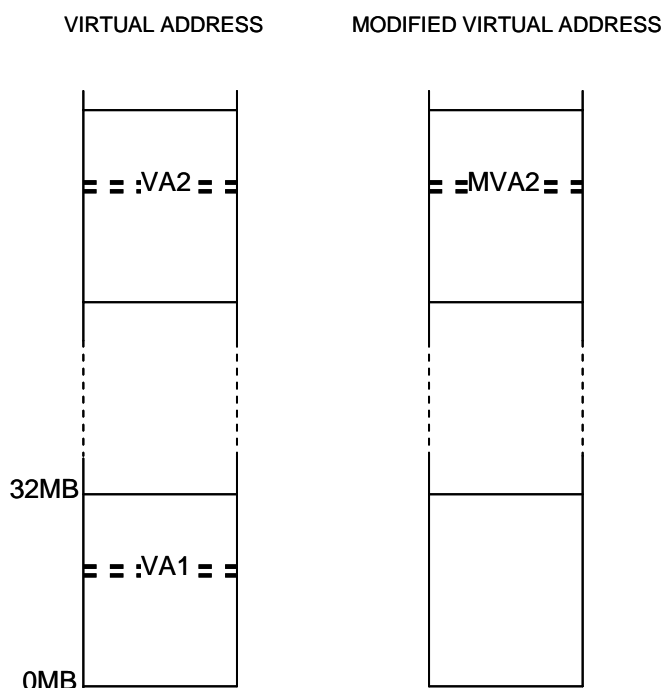
Both VA1 and VA2 (virtual addresses) are mapped to MVA2. VA2 will be the same as MVA2, and VA1 will be mapped to MVA2 by virtue of the value contained in the FCSE PID register.

If the data cache does not contain an entry corresponding to MVA2, and two subsequent read accesses are made to both VA1 and VA2, then a linefill will occur for the access to VA1, and under certain conditions, a linefill will also (incorrectly) occur for the access to VA2.

Either do not enable the data cache, or do not use the FCSE PID register.

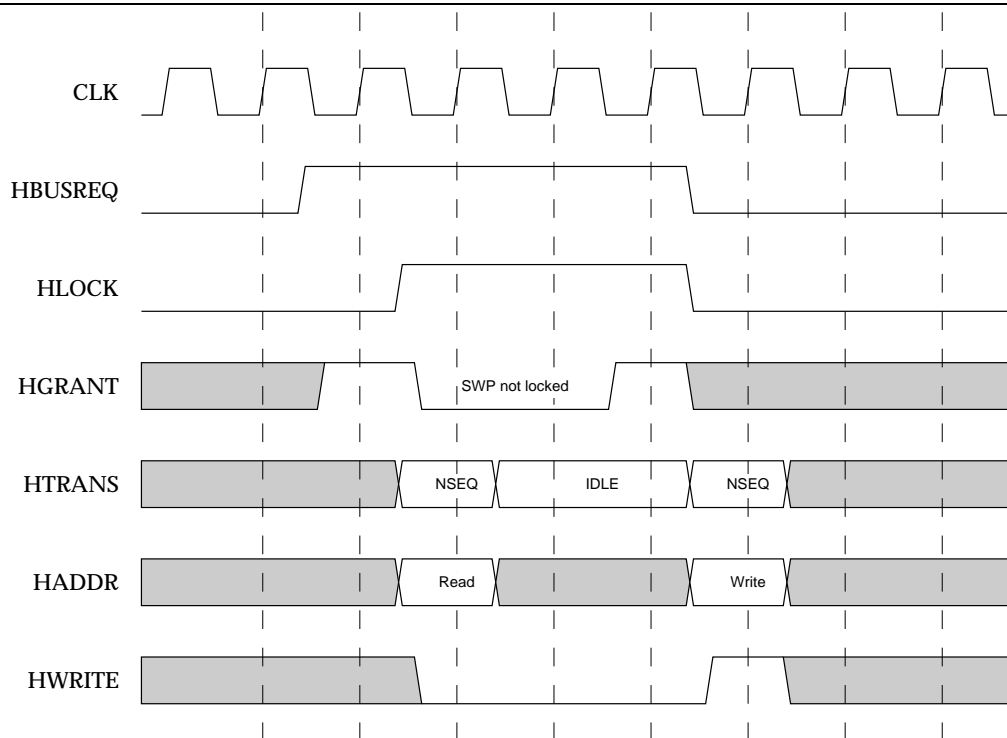
Figure 2: Incorrect HLOCK operation

Figure 2 shows the ARM926EJ-S behavior in non 1:1 CLK:HCLK modes. HLOCK is driven in the same cycle as the control signals (HTRANS, HADDR, etc) instead of in the previous cycle. The effect of the erratum is that the ARM926EJ-S may not gain locked ownership of the bus for the duration of the swap instruction and may be de-granted the bus after the read portion of the SWP. This allows another master to gain ownership of the bus after the read portion of the swap instruction, breaking the required semaphore behavior.

The AHB arbiter can be modified to prevent the ARM926EJ-S being de-granted during the SWP instruction. The logic to do this is shown in Figure 3. HLOCK_926 is DHLOCK driven from the ARM926EJ-S. HGRANTlast_926 is a pipelined version of DHGRANT driven to the ARM926EJ-S, indicating that the ARM926EJ-S owns the current address cycle (note that DHGRANT may be low during the address cycle as shown in Figure 2).. HGRANTlast_926 is registered using the positive edge of HCLK and using HREADY as a qualifier.

HLOCK_926 in the errata case has the same timing as required for HMASTLOCK driven from the arbiter. Therefore, OR'ing HLOCK_926 with HMASTLOCK will achieve the correct HMASTLOCK timing. HLOCK_926 must be AND'ed with HGRANTlast_926 as it is only valid to OR when the ARM926EJ-S is the granted master.
