ARM7TDMI-S Errata List

Document number: Date of Issue: FR002-PRDC-002719 7.0 20th March 2009

This document describes the known errata of releases rev2, rev3, rev3a, rev4p0-p2 and rev4p3 of the ARM7TDMI-S design.

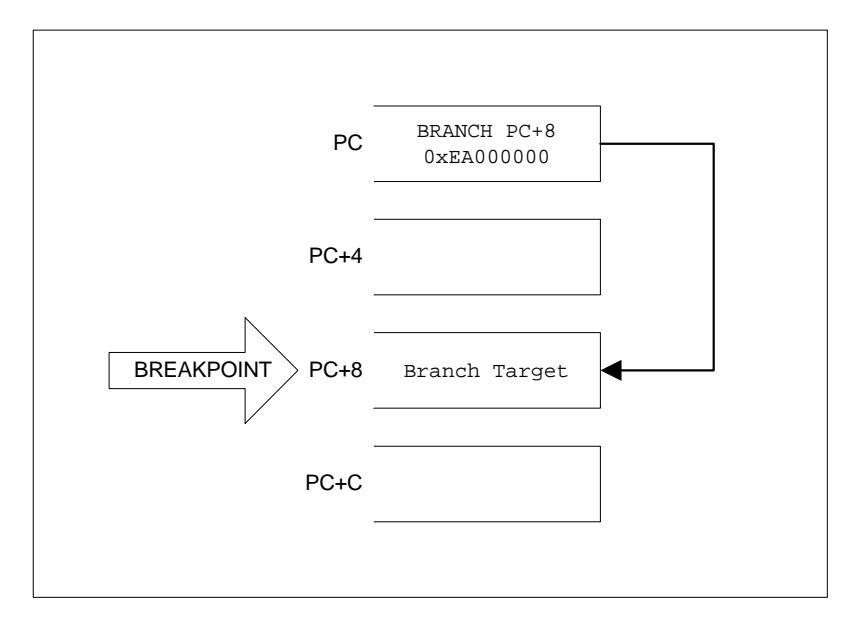
This case only affects the Branches to pc+8 in ARM State, and Branches to pc+4 in Thumb State. Other branch instructions are unaffected. The problem will only be encountered if the Branch is taken. If the branch is not taken, the breakpoint will be taken correctly. This branch could either be caused by an explicit branch instruction, or an instruction, which directly changes the PC, such as MOV PC, or LDR PC.

If a breakpoint is set on the destination of a branch to pc+8 (or pc+4 in Thumb State) the breakpoint will be ignored by the ARM7TDMI-S. This is due to the breakpointed instruction being fetched twice in consecutive cycles. The first is prefetch beyond the branch, and is discarded. The second is to re-fill the pipeline and is executed. The second breakpoint is not flagged correctly and the breakpoint is ignored. See diagram below.

This case can be encountered either if the user sets a breakpoint on the branch target, or if the user is single stepping through the case of a branch to pc+8.

With the current tools release users should be aware of this issue. If they suspect that a breakpoint has not been taken, they should set a breakpoint on the following instruction instead. When single stepping users should be aware that a branch to pc+8 cannot be single stepped, and place a breakpoint on the instruction following the branch target.

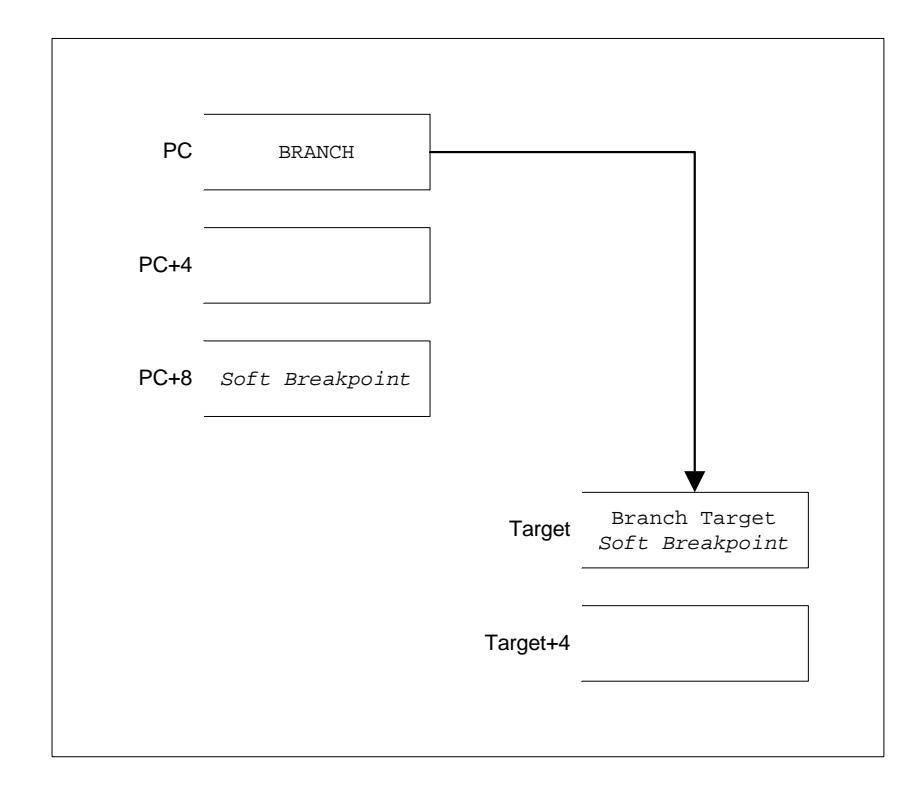
If multiple soft breakpoints are set in the memory, this condition can also be encountered. The case occurs where a soft breakpoint is set 2 instructions after a branch, and another soft breakpoint is set on the branch target. In this case the soft breakpoint value will be executed and the processor will not be stopped. See the following diagram.

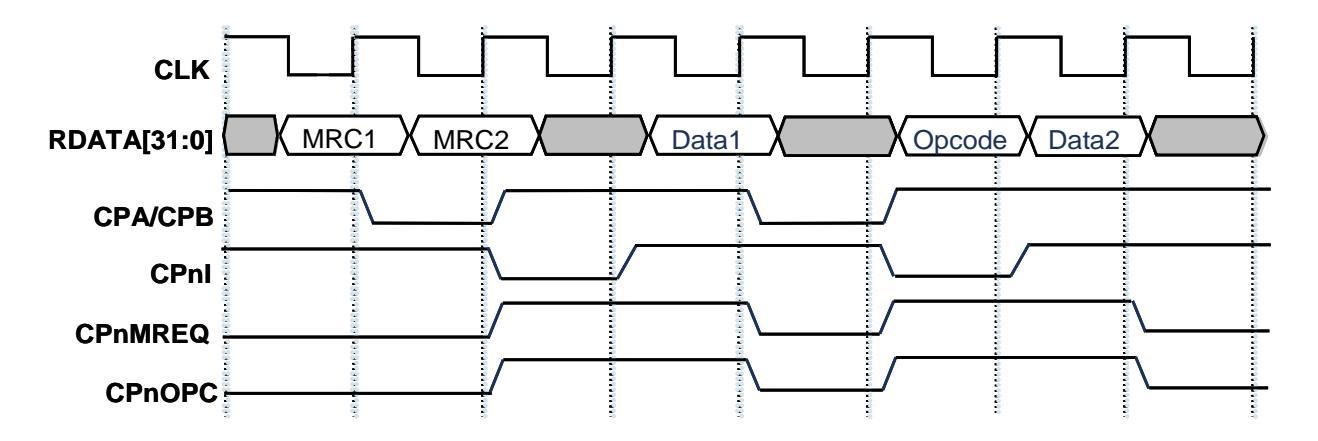
Fig 1: CPA/CPB as driven in the AVS testbench

Figure 1, shows how CPA/CPB are driven in the AVS testbench, causing the bug not to trigger.

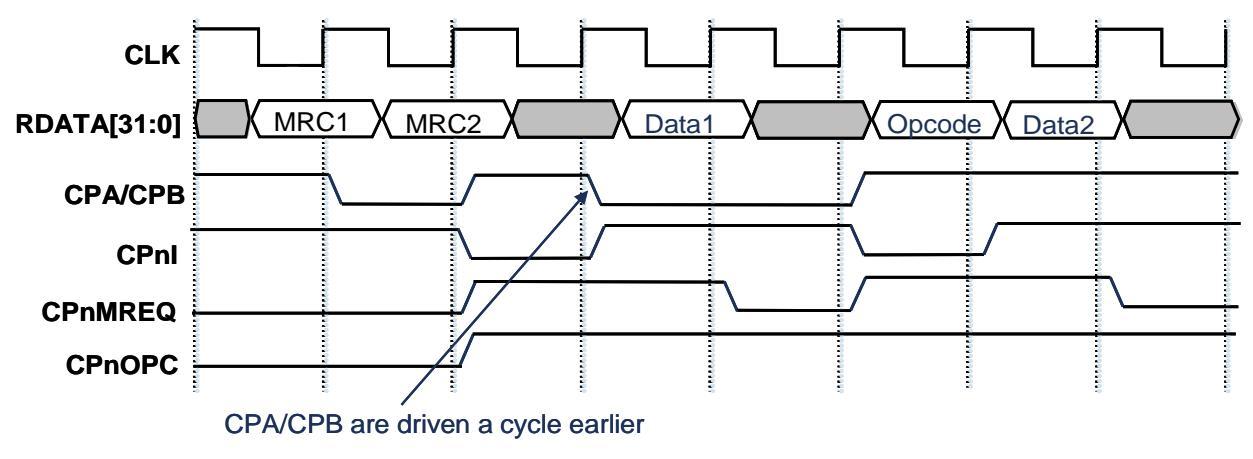
Fig 2: CPA/CPB driven a cycle earlier

The bug is only encountered if the value of <opcode_1> is set to 3'bx1x and only if CPA/CPB are being driven low by the coprocessor a cycle earlier with respect to CPnOPC/CPnMREQ going low.

Figure 2, shows how the bug is triggered, e.g. when $\mbox{CPA/CPB}$ are driven a cycle earlier by the coprocessor.
