ARM926EJ-S Errata List

Document number: **ARM926EJ-PRDC-002691 5.0**

Date of Issue: 28th March 2007

This document describes the known errata in the ARM926EJ-S design indicating which errata are present in each product revision.

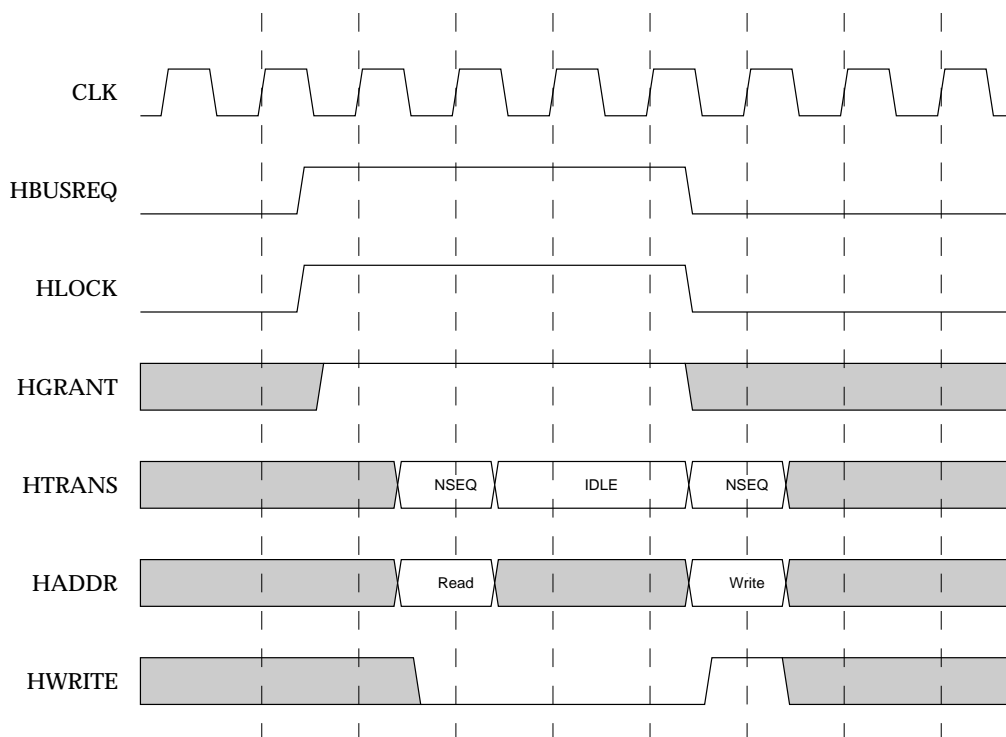
Figure 1: Correct HLOCK operation

Figure 1 shows the required HLOCK behavior. HLOCK is asserted with HBUSREQ at least a cycle before the read address of the swap instruction is driven on the AHB. The ARM926EJ-S follows this behavior in 1:1 CLK:HCLK mode.
