Arm Compiler for Embedded FuSa 6.16LTS

Defect Notification Report

Version July 2025

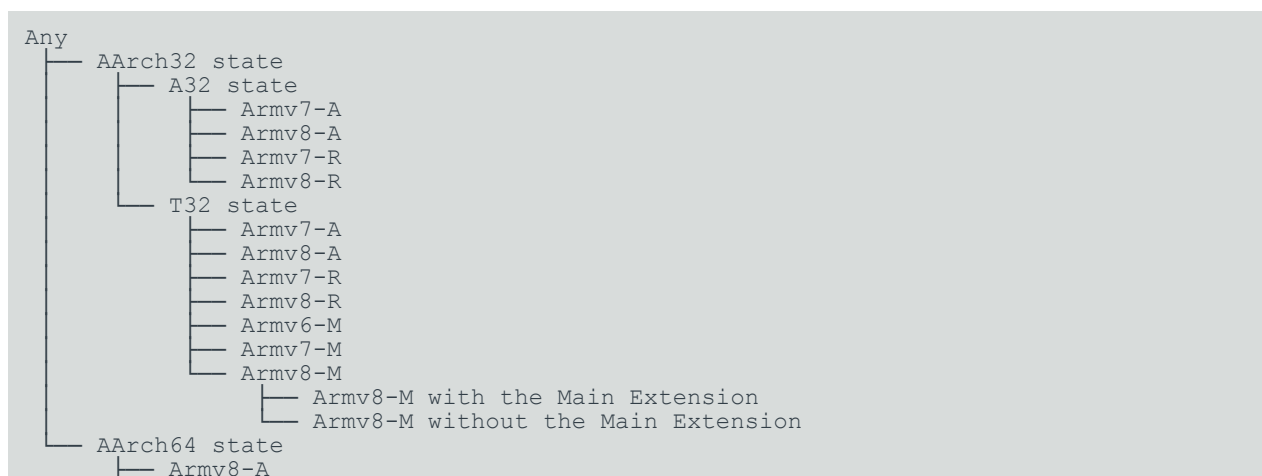
Architectures and processor states are not mutually exclusive, and their relationships should be interpreted inclusively. The following hierarchy illustrates how processor states and architectures relate:

└─ Armv8-R AArch64

A defect listed under a processor state, such as "T32 state", can apply to any processor or architecture that supports that state. Similarly, a defect listed under an architecture, such as "Armv8-A", can apply to any of the processor states that architecture supports, unless limited further by the Conditions section of the defect entry.
